Manhole Inspection Summary

Manhole # S03UU1020MH

Insp Date: **8/16/06 12:00 AM**

Location Address: **3701 Narcissus Ave**

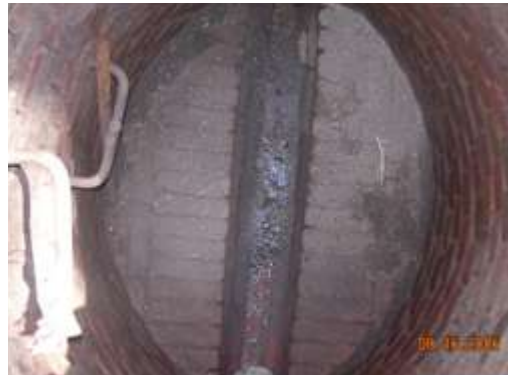
Top View

Adjustment loose brick. Adjustment and Corbel infiltration. Bench debris. Channel debris.

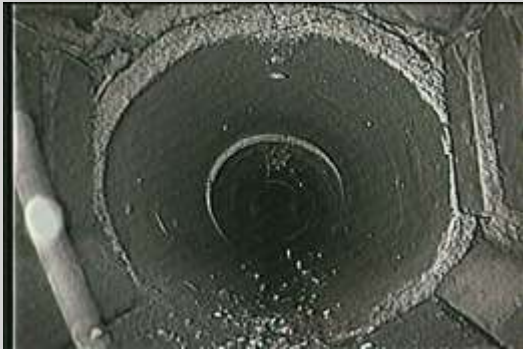
8 in. Circular Gravity Sewer Pipe Out @ 12 O'Clock

Infiltration: **Evidence** Pipe Seal Cond: **Unknown**

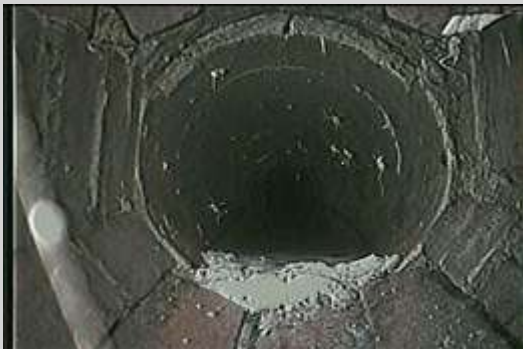
8 in. Circular Gravity Sewer Pipe In @ 6 O'Clock

Infiltration: **Evidence** Pipe Seal Cond: **Cracked**
